New York State Department of Transportation

Yellow Flag NB2222W002

By: Sahadeo Bhagwandin
Flag Date: March 25, 2022

BIN: 1065318
Feature Carried: 278I278IX2M23027
Feature Crossed: 6TH AVENUE
Orientation: 8 - NORTHWEST
Region: 11 - NEW YORK CITY
County: KINGS
Political Unit: City of NEW YORK
Approximate Year Built: 1962
Posted Load Matches Inventory : Yes
Bridge Load Posting (Tons) : Not Posted for Load
Primary Owner: New York State Department of Transportation
Primary Maintenance Responsibility: 12 - State - Subcontracted to another Party
Typical or Main Span Type: 3 - Steel, 02 - Stringer/Multi-Beam or Girder
This Bridge is not a Ramp
Number of Spans: 322

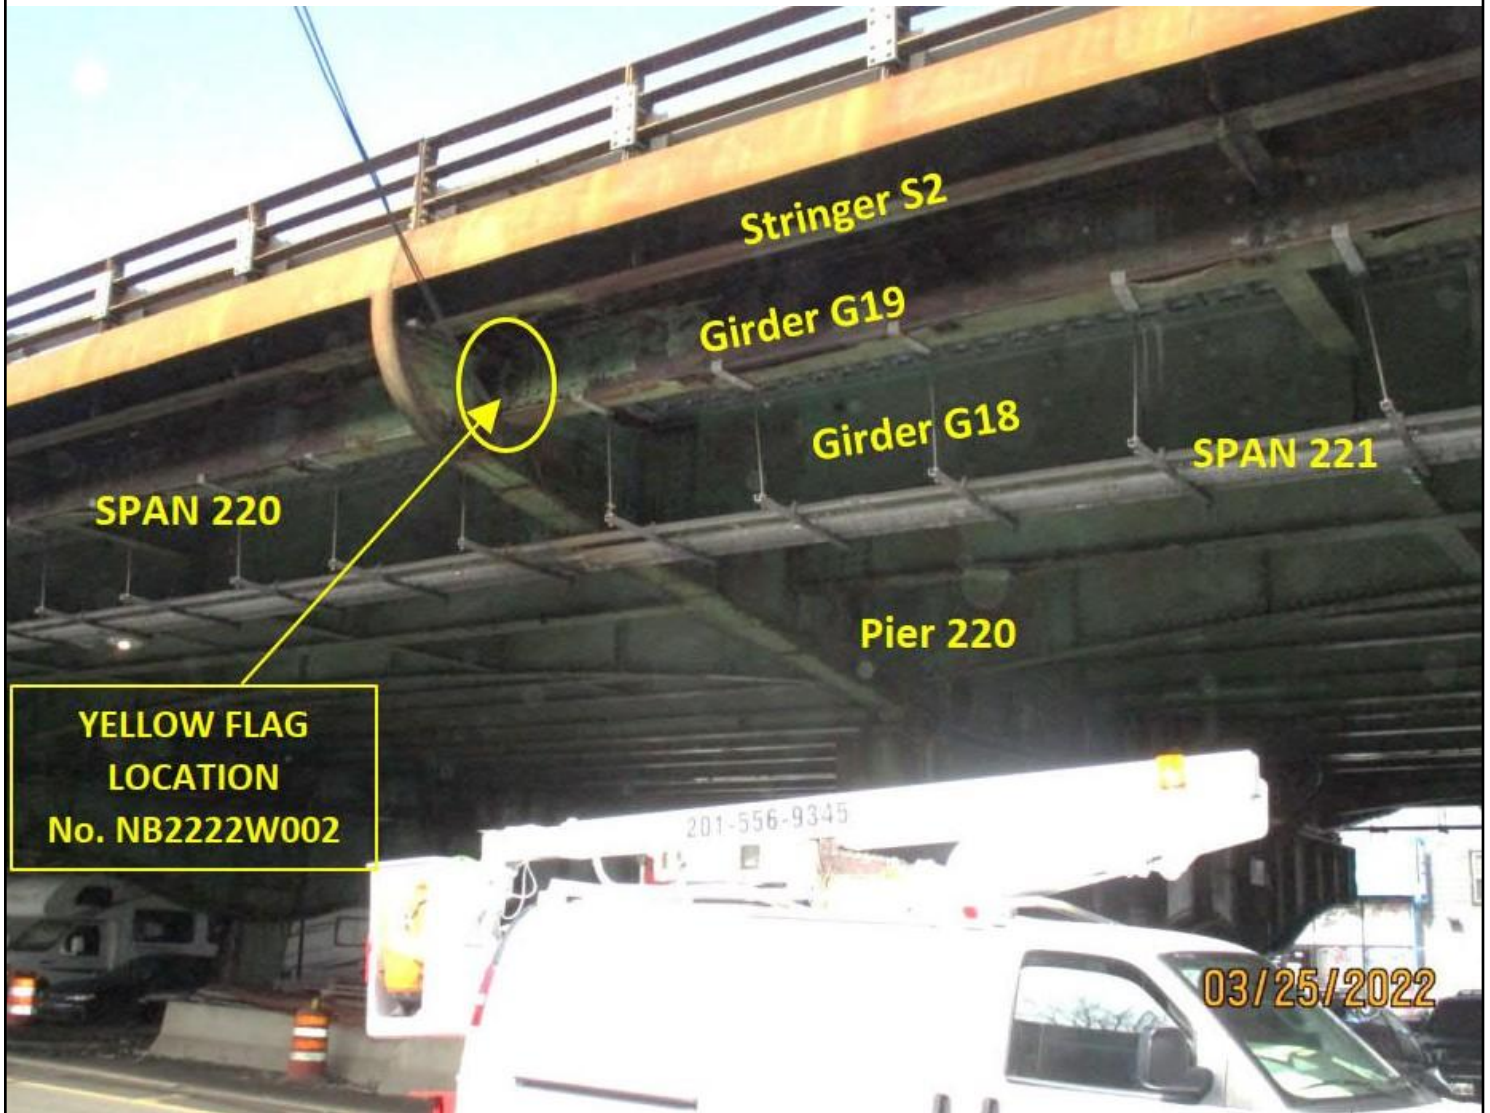
Photo Number: 1

Attachment Description: Span 221, Girder G19 at Pier 220. General view of flagged location at pier cap connection. Looking begin left.

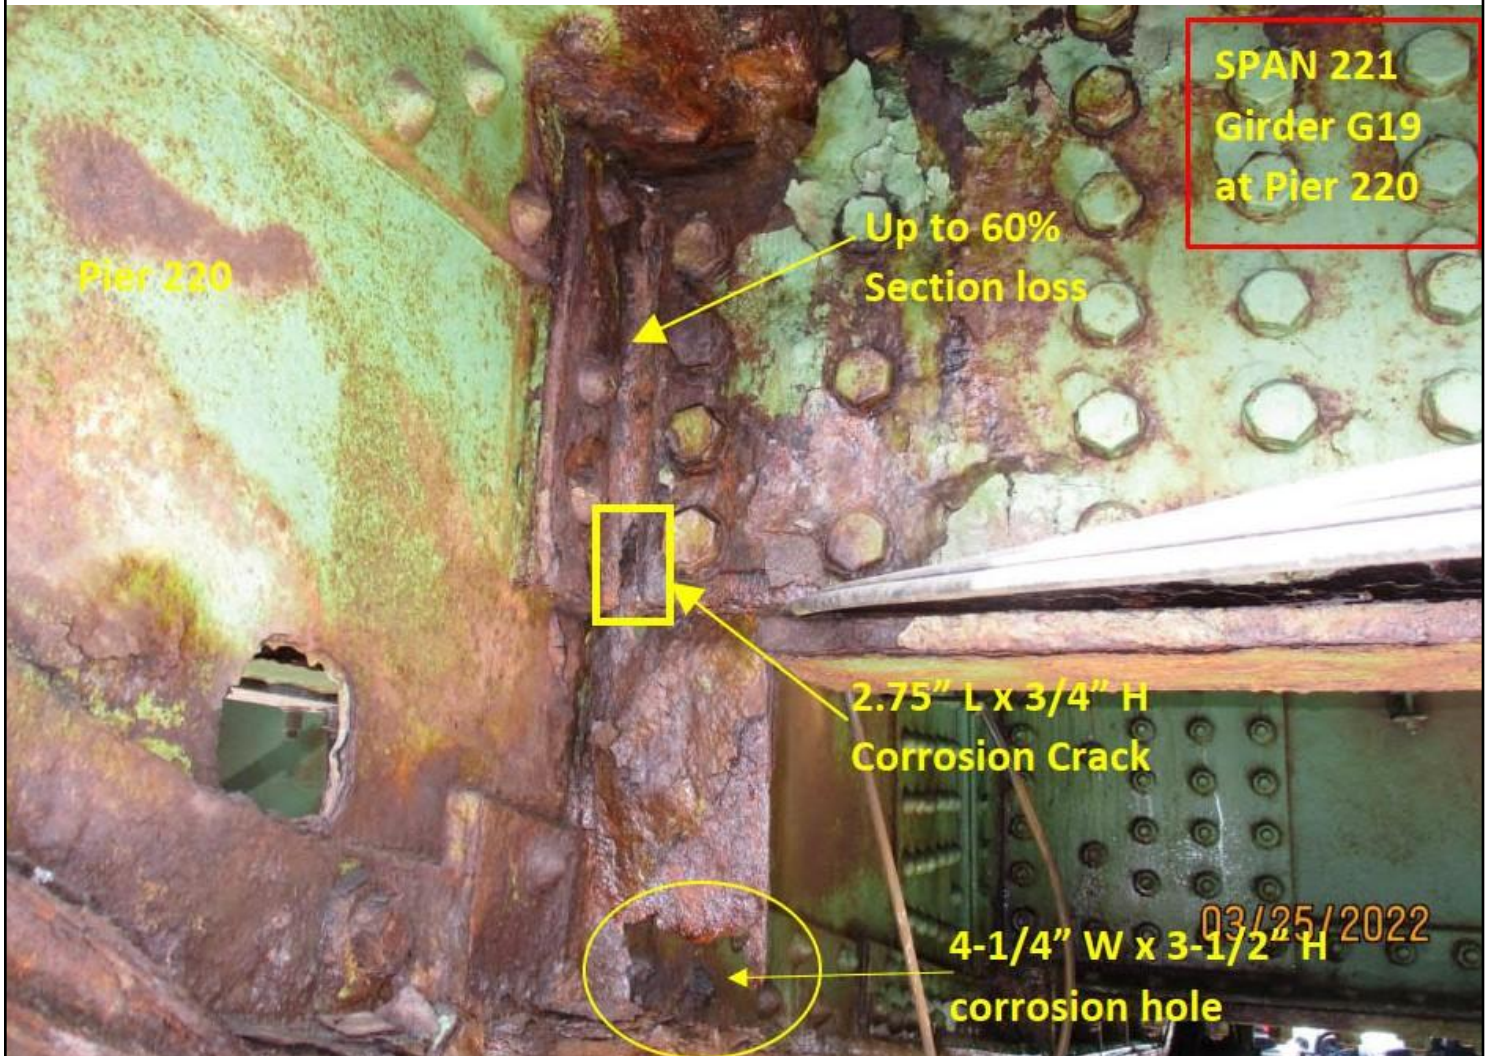
Photo Number: 2

Attachment Description: Span 221, Girder G19 at Pier 220. General view of the flagged location showing a 2.75" H x 3/4" W vertical corrosion crack at the lower fillet section, corrosion hole and up to 60% section loss at remaining section of connection angle. Looking begin left.

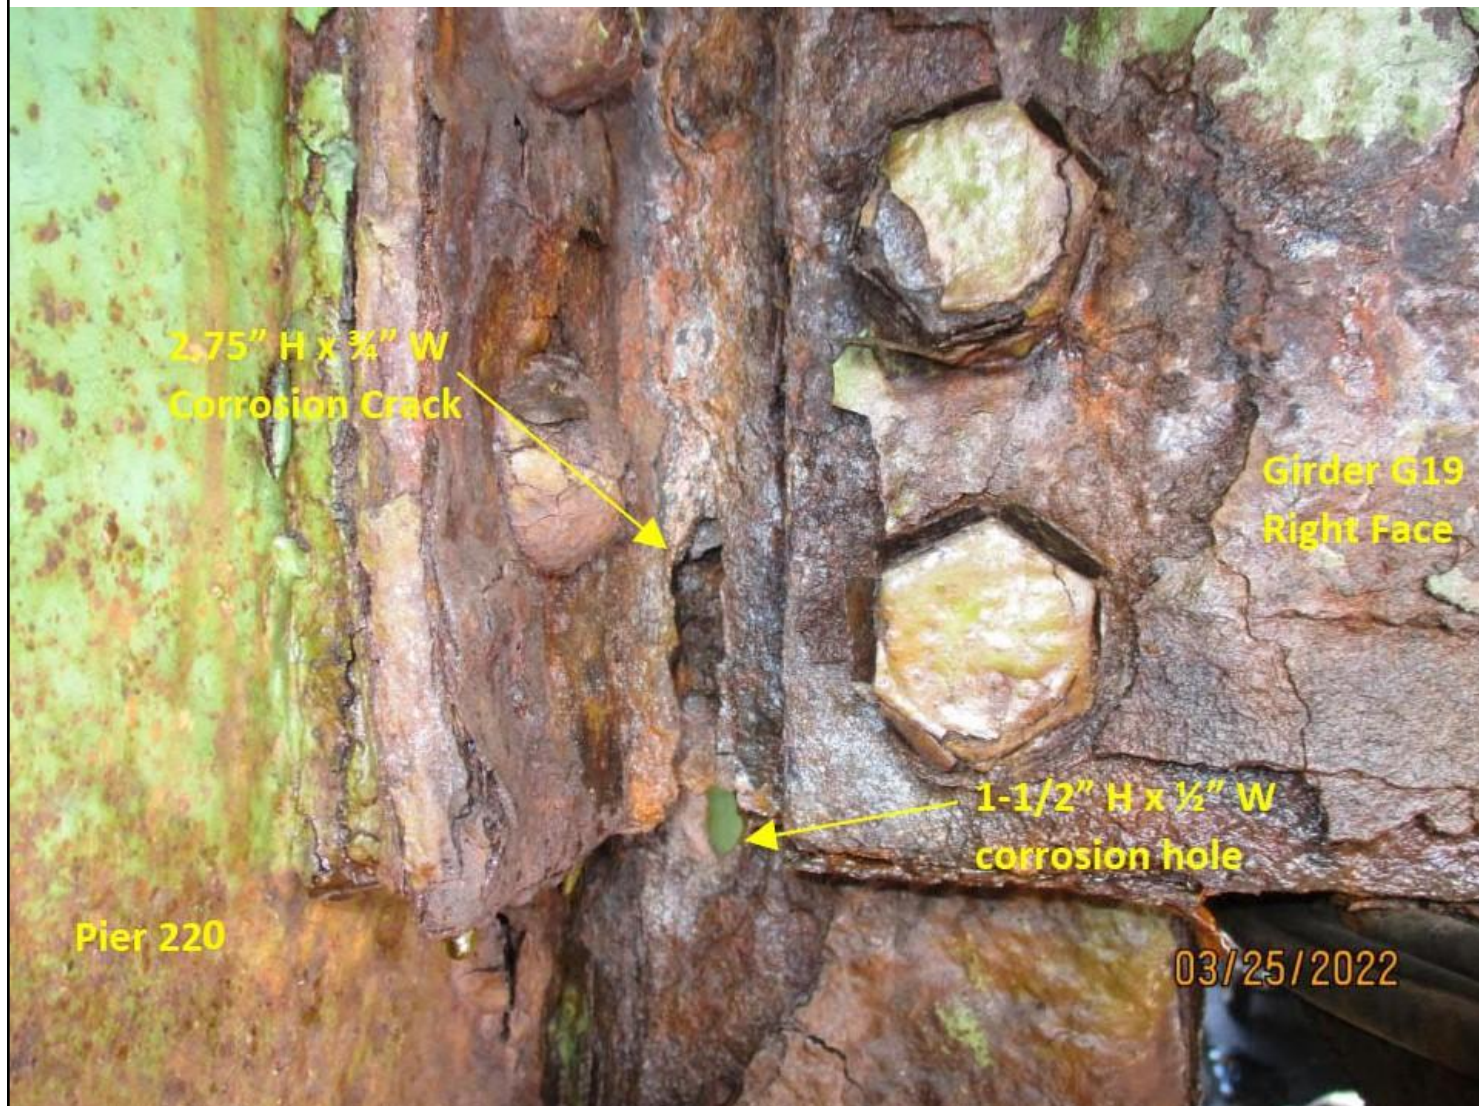
Photo Number: 3

Attachment Description: Span 221, Girder G19 at Pier 220. Close-up view of the flagged location showing corrosion crack, hole in connection angles and heavy section of the right connection angle. Looking left.

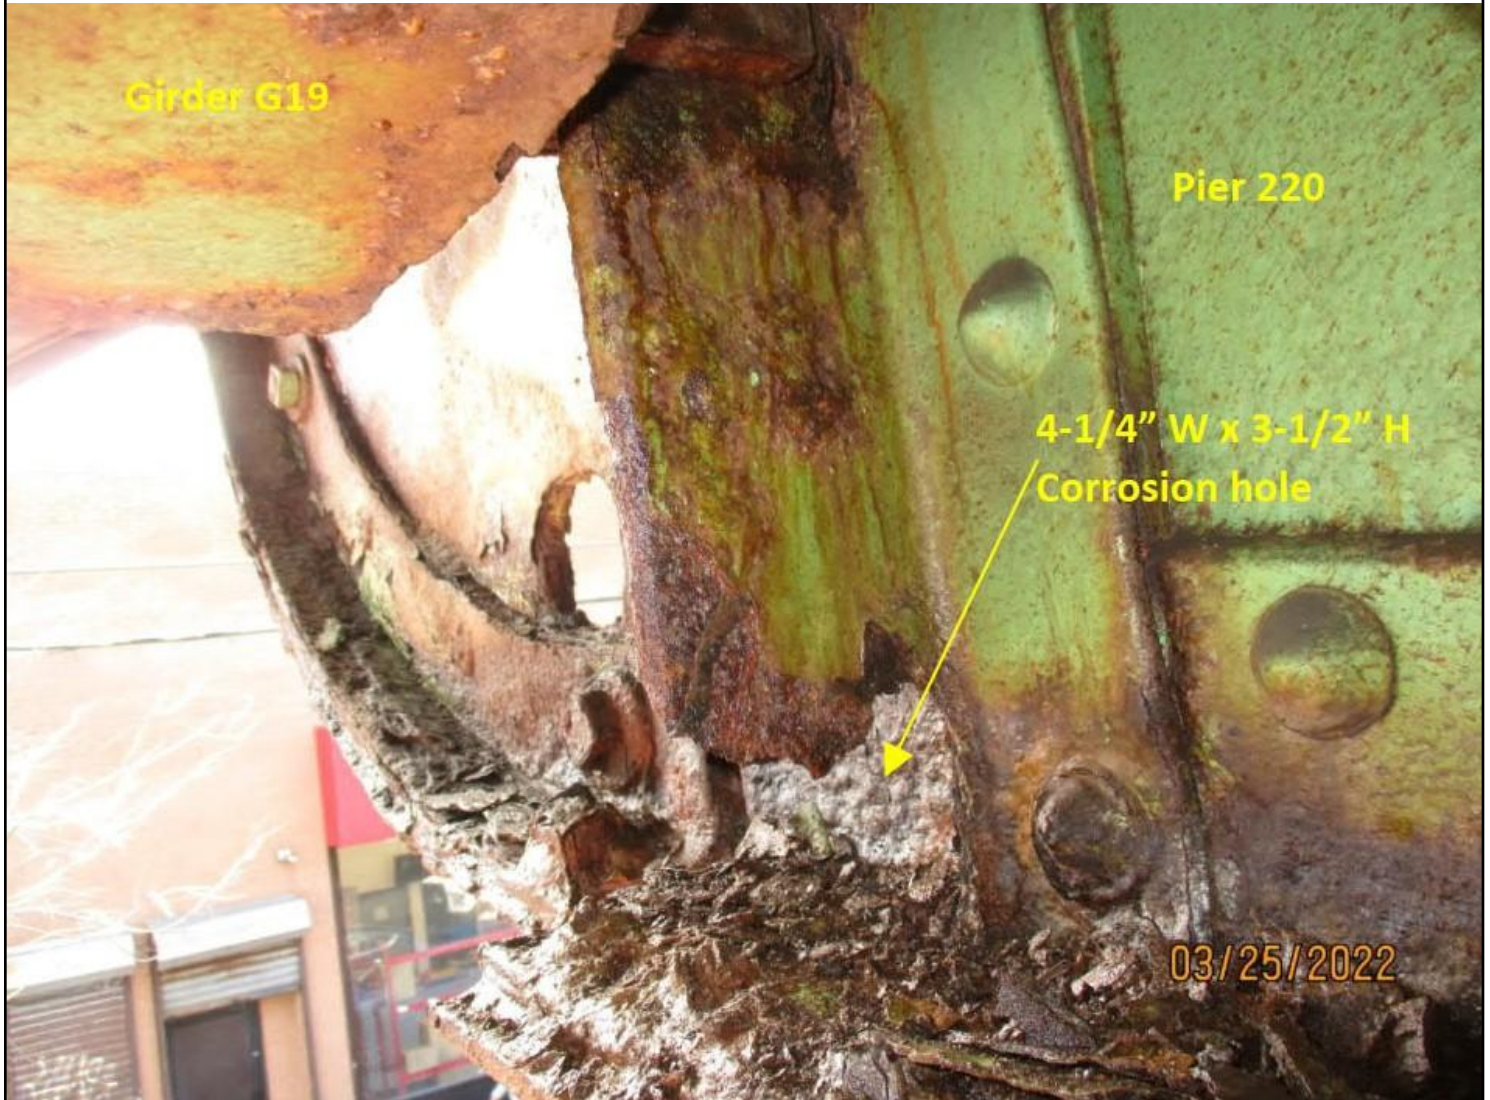
Photo Number: 4

Attachment Description: Span 221, Girder G19 at Pier 220. Close-up view of 4-1/4" W x 3-1/2" H corrosion hole at base of left side stiffener connection angle. Looking begin right.

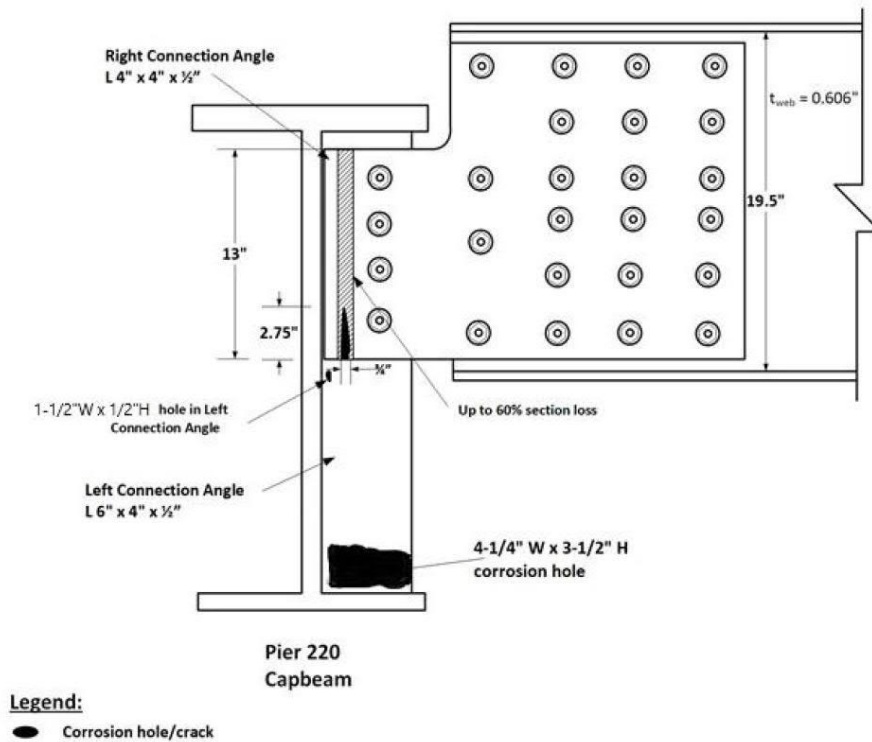
Span 221, Girder G19 at Pier 220(Looking left)

Attachment Description: Span 221 G19 at Pier 220 Sketch

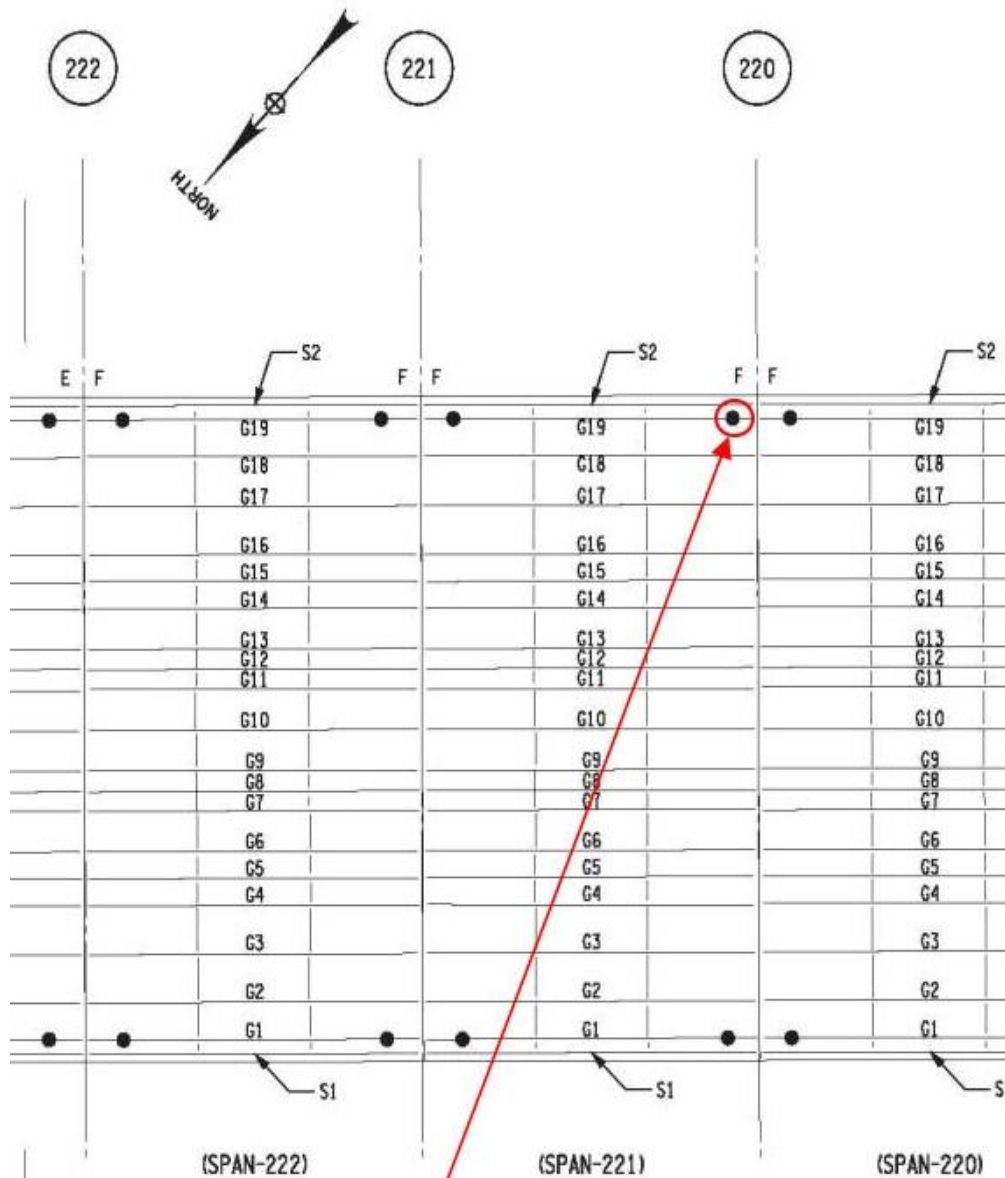
**YELLOW FLAG
LOCATION
No. NB2222W002**

Attachment Description: Span 221 G19 at Pier 220 Framing Plan
